## **In-situ compositional analysis of economiser tubes within the Sub-Boiler Annulus of an AGR pressure vessel**

### **Background**

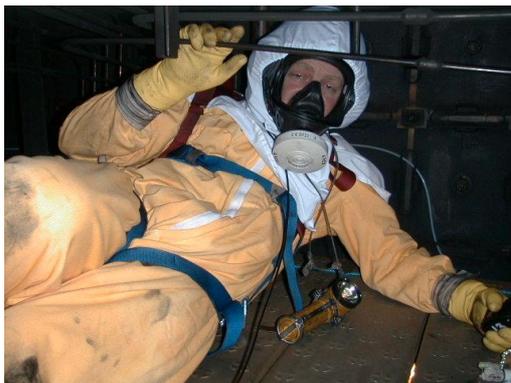
Access to the SBA was achieved by removing one of the gas-circulators and installing a temporary air-lock and change-room structure within the circulator port. As shown below, the vessel-entrants are required to wear protective clothing and equipment due to the nature of the environment. The fibre-optic umbilical of the LIBS instrument was fed into the SBA via a ventilation duct situated adjacent to the air-lock. Temporary scaffold towers were erected within the SBA to facilitate access to the banks of economiser tubes located directly beneath the steam generators and approximately six metres above the floor level, as shown below.

**Protective clothing required for working within the Sub-Boiler Annulus**

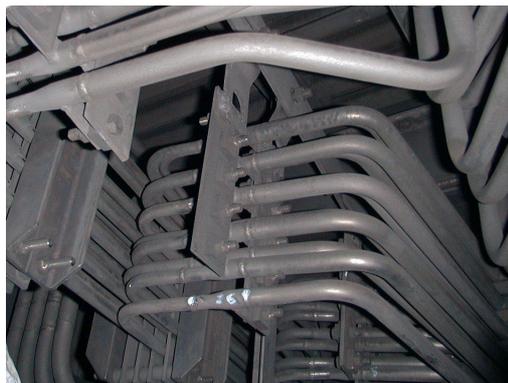
**View of a bank of economiser tubes situated ~6 metres above the floor of the SBA**

The LIBS instrument was deployed successfully at Hunterston B AGR power station in February 2001. Measurements of a number of tubes were carried out, the results of which indicated that the tubes examined were manufactured from steel having a chromium content of higher than 0.1% and hence were unlikely to be affected by erosion-corrosion. These findings were consistent with the results of previous video probe inspections of the internal bore of the tubes which showed that the tubes had not suffered from excessive erosion.
