## **In-situ compositional analysis of economiser tubes within the Sub-Boiler Annulus of an AGR pressure vessel**

### **Background**

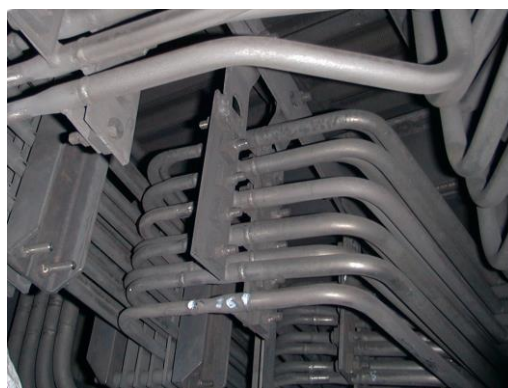
**View of a bank of economiser tubes situated ~6 metres above the floor of the SBA**
